NUMBER: 08-037-19 REV. B

Rear Window Defroster Inoperable

This bulletin involves inspecting and possibly repairing the terminal of the rear defroster circuit.

2017 - 2018	(JK)	Jeep Wrangler
2018 - Current	(JL)	Jeep Wrangler

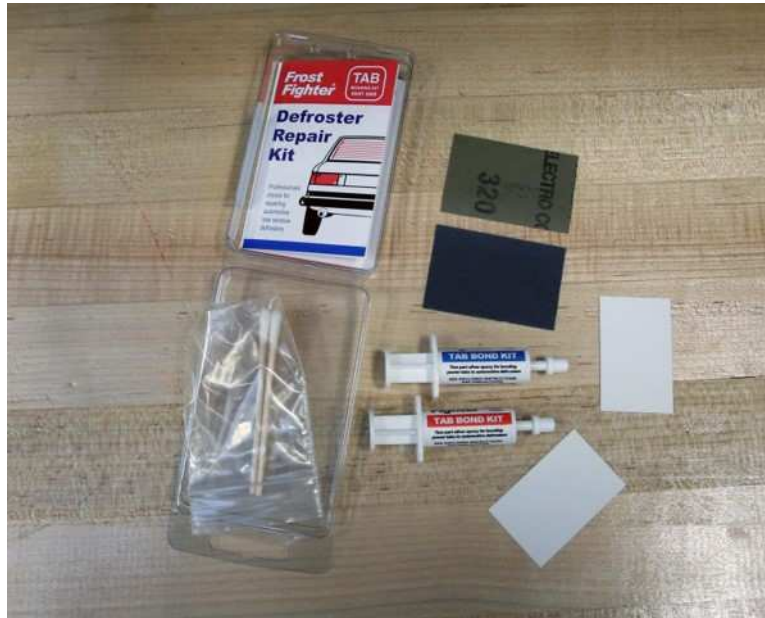
Fig. 1

For these vehicles it is recommended to use a Frost Fighter 2000® Defroster Repair Kit (Fig. 1) and if necessary Mopar #68428688AA, Tab.

Frost Fighter 2000 Defroster Repair Kit

NOTE: **FCA US has not determined any other product meets its specifications for electrical tab retention to glass.**

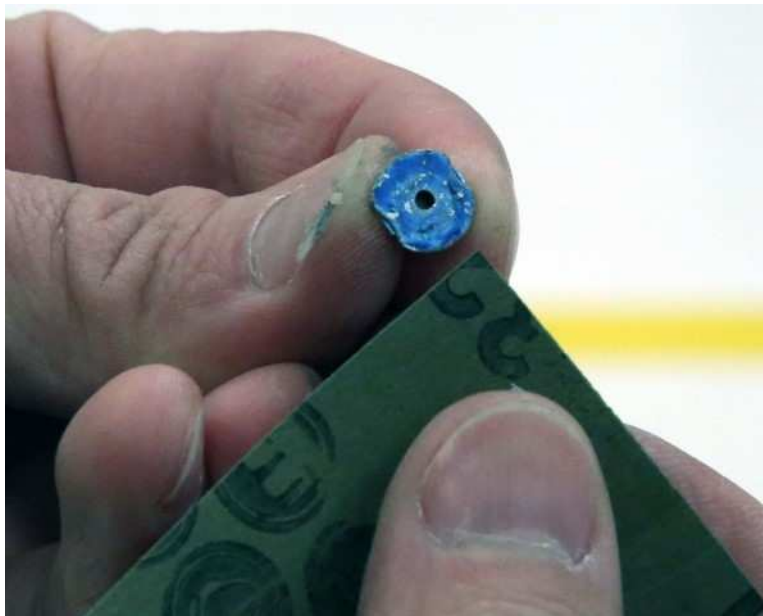
Fig. 2

NOTE: The flux that is pre-coated on the tab will cause adhesion issues with the epoxy. Remove before applying epoxy to contact point (Fig. 2) .

Rear Defroster Tab

For detailed repair procedure. Refer to the detailed service procedures available in DealerConnect> Service Library under: Service Info> 08 - Electrical / 8G - Heated/Cooled Systems / Heated Glass / Grid, Defogger / Standard Procedure> grid line and terminal repair.
